The Jersey Broadcaster

NEWSLETTER OF THE NEW JERSEY ANTIQUE RADIO CLUB

March 2014

TO RESTORE... OR NOT TO RESTORE

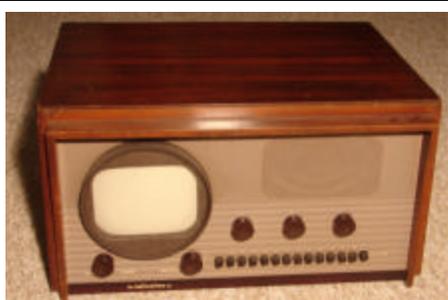
My T-505: The cabinet is in excellent condition with just a few scratches.

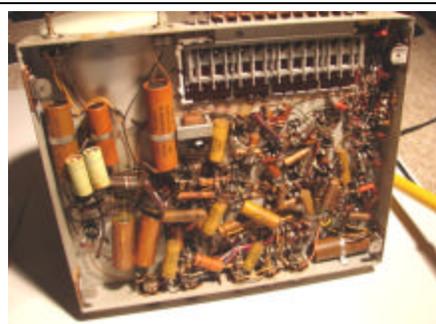
I counted some 35 paper capacitors that would need replacement.

5. I counted some 35 paper capacitors that would need replacement, some showing the typical signs of deterioration (i.e., melted wax on their ends). These included two huge, almost soda-can sized capacitors that couple the vertical output to the CRT. For most, the cost basis would be reasonable but the ones with a 6000 voltage rating, although obtainable, would probably run somewhat more. I'm estimating at least \$75 of replacement capacitor costs.

Most of the capacitors will be easy to replace, but the ones enclosed in the high voltage cage will take a little extra work. To remove the high-voltage cage, you must carefully unsolder several leads that run through holes in the chassis to a phenolic board underneath.

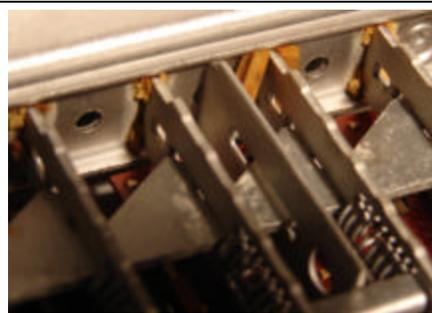
"...what appear to be brown, fiber 'necks' that surrounded each pushbutton shaft had completely deteriorated."

2. The mechanism that contained the row of pushbuttons for selecting Channels 1 through 13 worked perfectly. However, what appeared to be brown, fiber "necks" that surrounded each pushbutton shaft had completely deteriorated and the pieces could be found on the bottom of the cabinet. These "necks" seemed to have no mechanical or insulating function other than keeping the pushbutton shafts centered. I decided to write to a restorer I found on the Internet to get further information that I am still awaiting.

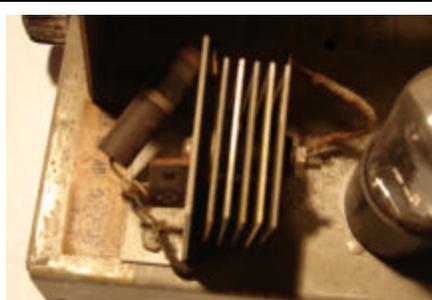
The selenium rectifier in the low voltage power supply would require replacement with solid state devices.

7. The selenium rectifier in the low-

voltage power supply will require replacement by solid-state devices. (The negative and positive low-voltage power supplies are transformerless, and one side of the power line is grounded to the chassis. For this reason, precautions must be taken such as verifying the integrity of the insulation of the hold-down brackets from the chassis.)

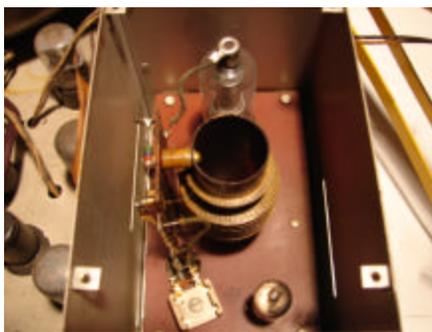
The high voltage power supply will present a unique restoration challenge.

6. The high-voltage cage contains a 6C4 HV oscillator tube, a 1B3GT HV rectifier, the HV coil and a few other components. Unlike modern sets that use the horizontal sweep for the input to the HV section, this set has an air core transformer and separate oscillator that runs at a much higher frequency. The complex construction of the HV coil with its stacked windings makes it nearly impossible to replicate. Fortunately, all components within the HV cage were found to be clean and free from any carbon tracks. Although a tricky procedure, the capacitors under the HV cage would require replacement for reliable operation of the circuit.

The high voltage output should run from 5-6 kilovolts at a frequency of about 200 KHz. Lower values give a dim picture that might inaccurately suggest that the CRT is bad. Therefore, it is important that the HV supply is operating within specifications. However, it has been found by some restorers that the HV supply in Hallicrafters TVs (and similar Philco 7-inch sets) may present problems. In many cases, merely restoring components to original values doesn't necessarily produce the required HV.

The culprit is the HV r-f transformer coil that appears, in some (but not all) Hallicrafters T-54 and T-505 sets, to lose its "oomph" over time, perhaps because it absorbs moisture or suffers some other unknown failure mode. Collectors have tried various remedies, such as baking the coil and recoating it, modifying circuitry to boost the drive voltage, or even installing a substitute HV supply. One restorer installed a little muffin fan in the HV cage and lifted the lid a bit to improve ventilation but the fix is only temporary. Another collector, after discovering a leaking HV coil, found one with the same diameter and number of turns on the secondary. So he cut both coils in half and combined the old primary with the new secondary, gluing them together with silicone and insulating them with Krylon.

The bottom line is that even if a perfect restoration is obtained, design problems with the HV power supply may limit the operation of the set to only a few hours as the HV r-f transformer coil could reabsorb moisture or suffer some other failure mode.

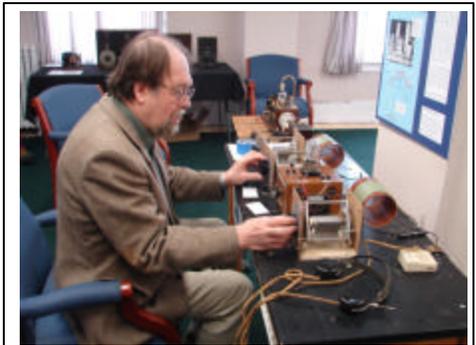
Al Klase adjusts his virtual receiver.

One of the highlights of my day was Al's mock-up of Armstrong's original circuit, receiving simulated spark radio-telegraph transmissions from Clifden, the Poulsen stations at San Francisco and Honolulu and the Salby-Arco alternator in Nauen, Germany. Al describes his simulation as the Radio Technology Museum's "way-back machine" which "has the ability to fold space so we can hear the same signals Armstrong and Sarnoff heard 100 years ago." For those of you who are technically motivated, here's Al's description of the details of how he produced his virtual ether:

"A 120 hertz square wave was used to excite a parallel tuned circuit at about 800 kHz. This produced trains of damped waves with a "spark rate" of 240 hertz, the reported sound of Cape Cod (MCC). Out put was about a microwatt, which represents a pretty strong signal when applied directly to the antenna terminal of even a primitive receiver. The transmitter was keyed by a Morse signal generated by a personal computer to make the original recording."

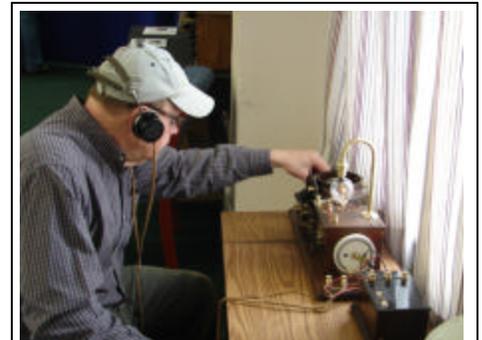
DX'ing with a spherical audion receiver.

A special treat was provided by Eugene Hertz (W2HX) who loaned a homebrew "audion-based" receiver to the displays. With the help of Steve Goulart, a long wire antenna was set up and we had a lot of fun trying to log in as many stations as possible. Nevell Greenough showed a trick he learned from QST in getting the most out of one these types of receivers; it involved a lot of hand manipulations.
