# The Jersey Broadcaster

NEWSLETTER OF THE NEW JERSEY ANTIQUE RADIO CLUB

June 2015

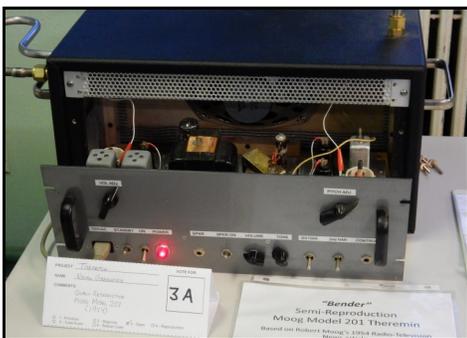
For Category 3 (Open), member **Nevell Greenough** entered a "Bender" semi-reproduction of the Moog Model 201 Theremin based on Robert Moog's 1954 *Radio-Television News* article. The unit is housed in a 1950's style guitar-amp cabinet using as much of the original circuitry as possible. It's a very impressive piece of electronics comprising 7 tubes and about 5 IF transformers. The "Bender" emblem is based on the "Fender" guitar amp design and was produced on a 3D printer. Revealing himself to be a closet musician, Nevell can even play the thing a bit. Leon Theremin would be proud!

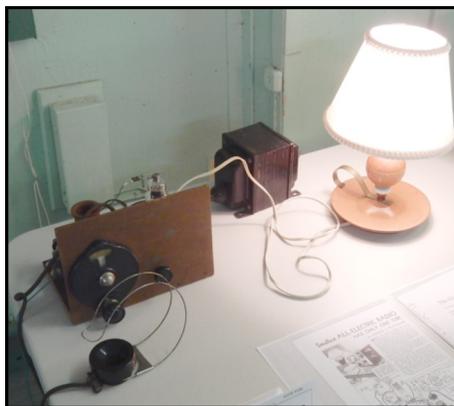
**John Ruccolo's** Category 4 (Vintage Reproduction) entry was billed as the "Smallest All-Electric Radio" in a Thomas Blanchard construction article from *Modern Mechanics*. It is based on the little-known 12A7 tube, a power pentode and rectifier diode in a single 7-pin envelope. It's a simple AC/DC regen with plug-in coils. The dropping resistor for the 12-volt heater is a cute bedside lamp holding a 40-watt bulb.

The article notes that "the set will cover both the short wave and broadcast bands, bringing in police calls, phone broadcasts, code and phone amateurs, and perhaps even a foreign station or two under good atmospheric conditions."

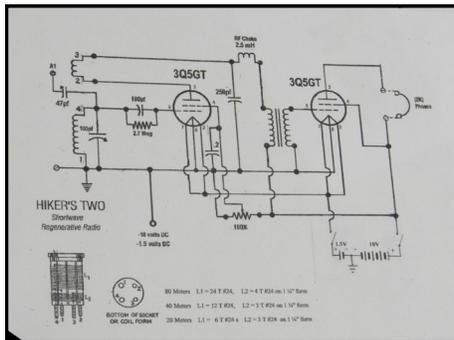
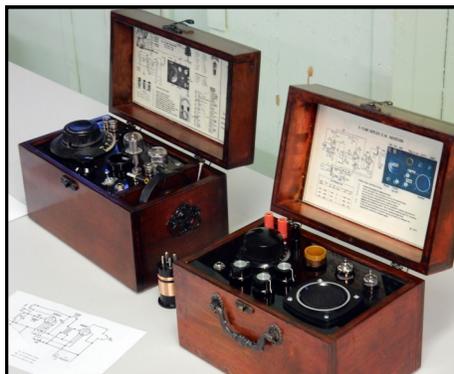
New member **Bruce Ingraham** showed off two very nicely done two-tube short-wave regens in homemade wooden cabinets. For competition purposes, we chose the "Hikers Two" based on 3Q5GT tubes to stay within the two-tube functions of Category 1 (Primitive Receivers).

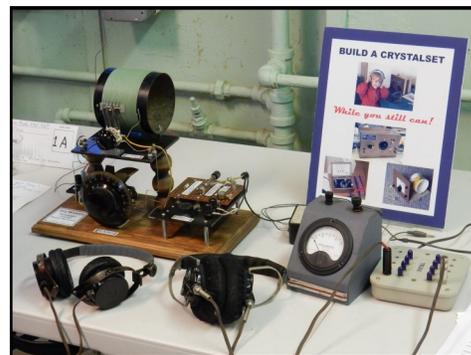
Member **Al Klase** demonstrated a Steam-Punk crystal set now on display in our Radio Technology Museum. This is another example of Al's "Pretty Good Crystal Set" design. Connected to a 100-foot antenna, and driving a sensitive sound-powered headset, it gave a good account of itself. Folks seemed to enjoy pinning the 50-microamp "S-meter" in series with the detector by tuning in a strong local station. Not an "official entry," it was displayed to encourage the building and preservation of crystal sets. (See <http://www.skywaves.ar88.net/xtal/Xtal.htm>.)

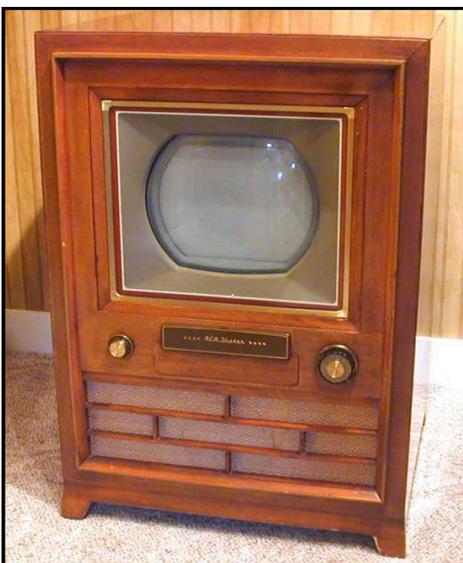
The CT-100 at the Early Television Museum. Its original price in 1954 was \$1,000 but, after heavy advertising failed to sell many sets, its price was dropped to \$495. Shortly after that, RCA perfected its 21-inch tube, and recalled most of the CT-100s, swapping them for the new 21-inch set for free. It is estimated that about 160 still exist today, hopefully one eventually being at the NJARC Radio Technology Museum.
