The Jersey Broadcaster

NEWSLETTER OF THE NEW JERSEY ANTIQUE RADIO CLUB

November 2015

**PHILCO'S
"SPECIAL SERVICE"
BAND**

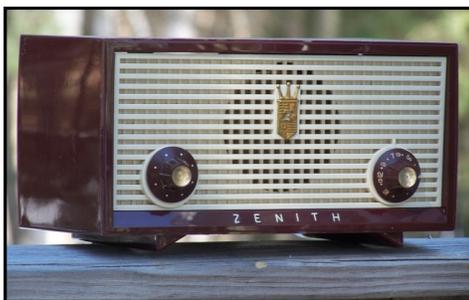
A classic 50's Zenith.

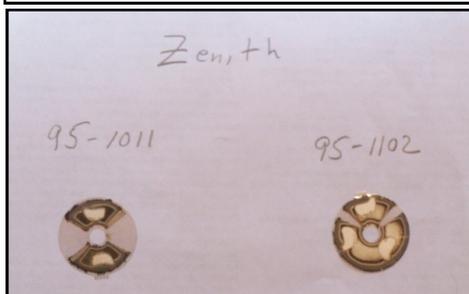
Figure 1: "Diseased" capacitors.

As I'm sure most of you know, no two IF cans are alike. In my case the capacitors for the IF's were built into the base of the can. They were made of a single mica disc with a silver coating (see Figure 1). Internally, the disc is situated between two shoes.

Trying to take a reading of "diseased" capacitors is nearly impossible. You will need to disconnect each coil connection to take any readings. The readings I obtained on the caps of the part number 95-1011 IF can were not even close to each other. How was I able to obtain the value of a relatively workable replacement?

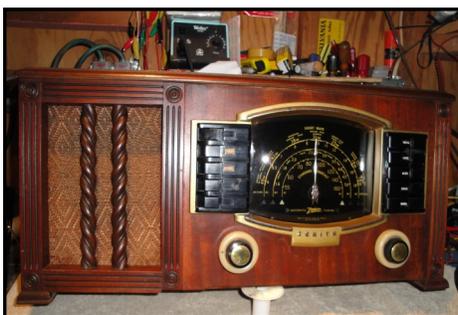
A beautifully restored Zenith 7S634 attests to the fine work of NJARC member Bob Bennett.

where it took Bob Bennet, Nevell Greenough and myself close to half a day to get the knobs off Todd Edward's Zenith 7S634 so the chassis could be removed and worked on. Todd had saved the radio from the trash 30 years ago and the broadcast band came in loud and clear after just a tube socket cleaning. Todd then asked Bob Bennett if he could perform a recap and repair of the SW bands.

The radio had a broken ON/OFF switch which Bob said he would repair by mounting a replacement switch on the rear. Fortunately, Bob found a similar Zenith in Kutztown that had a melted transformer but good switch; he purchased it for \$20. About 15 capacitors, three resistors and an ON/OFF switch later and a cleaning of the SW band switch, the Zenith was back to its full glory for another "satisfied customer."

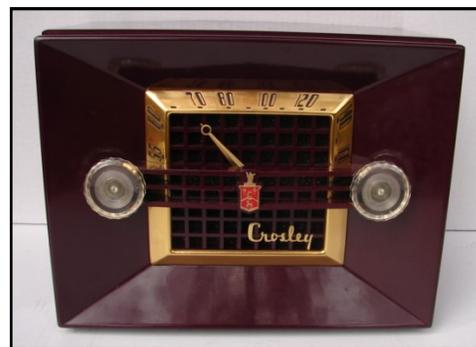
- I had purchased a very nice Crosley 11-108U some years ago in working condition. I recently fired it up and could only get static. Ugh! Not another case of silver mica disease! I left it on the shelf for a few months and figured I could work on it at the clinic. The night before, I decided to try the radio again and found that the tube filaments did not even light.

After pulling the chassis and getting ready to get down to business, a client showed up and I was put on a new track. Member Nevell Greenough had just checked out an Eico 460 and B&K 1460 scope for president Richard Lee and appeared bored so he volunteered to look at my Crosley. It wasn't long before Nevell found a broken ON/OFF/VOLUME switch, easily repaired it and presented me with a working radio.

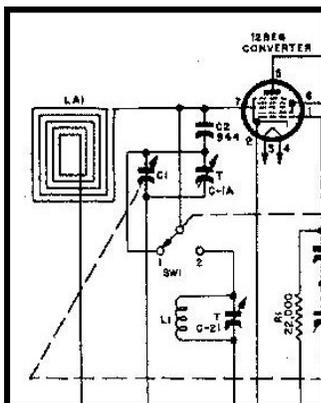
Figure 1 - Front end of Philco Model 53-561 showing special service switch (SW1) in "BROADCAST" position. L1 and C-21, in parallel with the tuning capacitor, are the service band components but their values are not identified. C-21 is a trimmer which is adjusted for maximum output at 3.2 MHz.

Now the question arises as to why would Philco gamble on consumers paying extra money for a feature that might not be all that appealing? Well, the answer is very simple...parallel resonance. Philco did not have to switch oscillator frequencies to have this band; all that was required was to include a few extra components in the tuned detector circuit that could be switched in at the front end and

produce a resonant frequency between 1.7 and 3.4 MHz (see Figure 1). Once heterodyning took over, the IF remained the same! It was a low cost sales gimmick that did not require a big increase in the price of the radio but could be used as a sale advantage.
