# The Jersey Broadcaster

NEWSLETTER OF THE NEW JERSEY ANTIQUE RADIO CLUB

July 2024

## Repairing IF Transformers with Silver Mica Disease (or, How I Stopped Worrying and Learned to Love SMD)

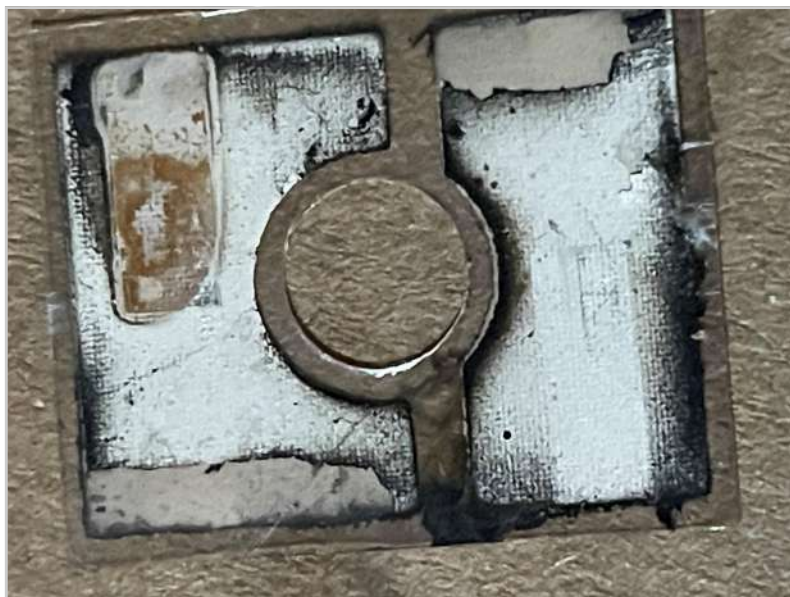
Here is a picture of a mica sheet showing the migration first hand. The white areas are the two silvered areas on the mica sheet, and the black areas are the migrated, tarnished silver. You can see where the short happened at the bottom of the picture:

Since the migrated silver is so fine, it can't handle the current and immediately opens up, causing a crackle like the static you hear from a thunderstorm on your radio. Over time, as more silver migrates, this happens more often, until you hear nonstop static, sometimes with the radio still playing, often not. A popular YouTuber who goes by the handle of Shango066 captured the mayhem with night vision goggles here: <https://bit.ly/3Lh9sw6>. It's quite impressive!

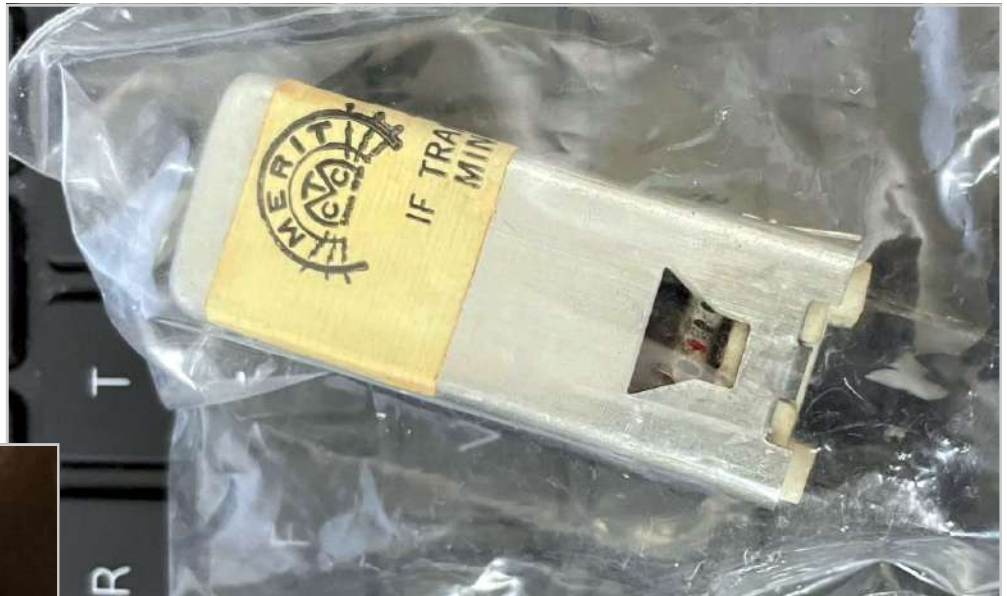
If you are lucky, you can sometimes find better quality aftermarket parts that did have real capacitors inside, not the flawed mica sheets. Here is an example of a Merit part that had tiny little tubular ceramic capacitors inside (if you find these, you hit the jackpot): If you aren't so lucky to win the jackpot with a quality Merit part, or were burned with a diseased used IF transformer inside that box that you thought held a brand new part, no worries. We can still take these apart to fix the problem!

Example of IF transformer with ceramic capacitors inside

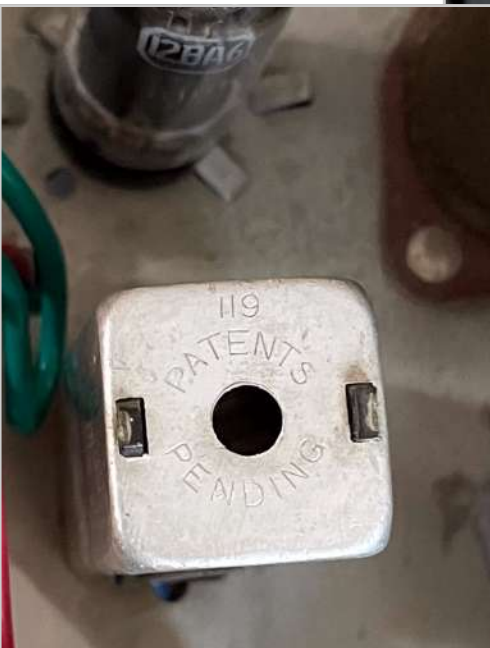
Automatic IF transformer

I can't give you detailed instructions for every possible transformer design, as I've seen over the years that radio manufacturers used IF transformers from multiple suppliers, and each one built them a little differently. Having said that, the most prolific supplier to manufacturers during the 1950s was a company named Automatic, and those will have the number 119 stamped on top, two plastic tabs projecting up through the top, and usually (though not always) the words Automatic or Automatic Manufacturing stamped on top as well.

On the bottom will be a metal rivet that needs to be cut out to take it apart to get at the mica sheet. I personally like to use a dremel grindstone to gently grind away this rivet until there's enough metal removed to gently cut out the remainder with a small set of flush cut snips. Once you have the rivet cut free, there is a plastic top cap that needs to come off to get access to the mica sheet.

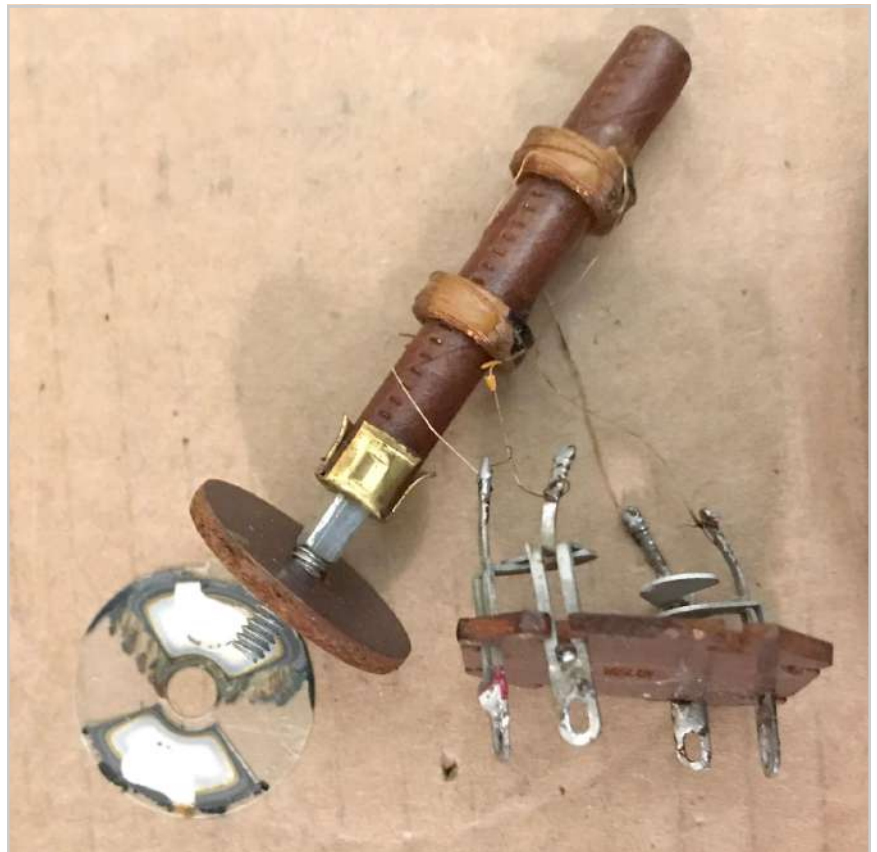
Here is a Zenith part# 95-1101 IF transformer totally disassembled so you can see how it comes apart. Since I took this picture, I stopped doing it this way, instead backing out that retaining nut just enough to get the flush cut snips and my tweezers in there to take out the mica sheet in sections rather than risking those hair thin wires. Although those wires can be spliced back together, trust me it takes the steady hands of a surgeon to do it!

Once the mica sheet is out, those contacts need to be insulated or cut out enough to not make electrical contact. You will be using modern mica or COG/NP0 ceramic capacitors to replace that diseased mica sheet, so you don’t want to short out your new capacitors (you’ll be installing them underneath, outside the can). On the next page I show some examples of how I put the Zenith and Automatic IF transformers back together. For Automatic, you’ll need a gentle adhesive to hold everything back together. I personally use a small amount of liquid electric tape, applied using a dental pick. It’s designed for insulating electric wires, so it provides a strong bond without emitting fumes during curing that could damage those delicate copper wires.

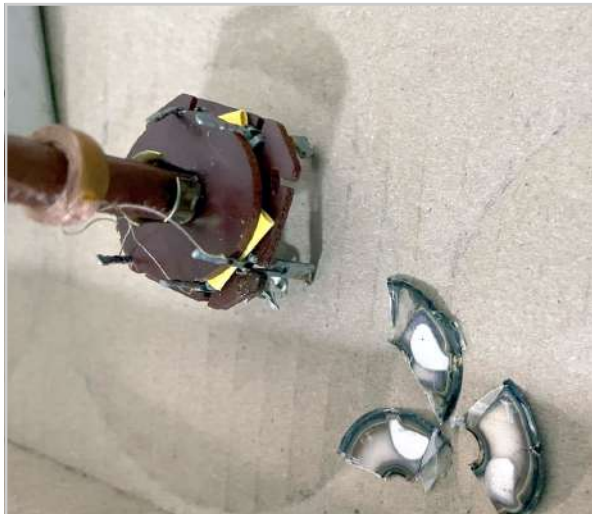
Zenith reassembled. (I used a little heat shrink tubing to insulate those mica sheet contacts.)

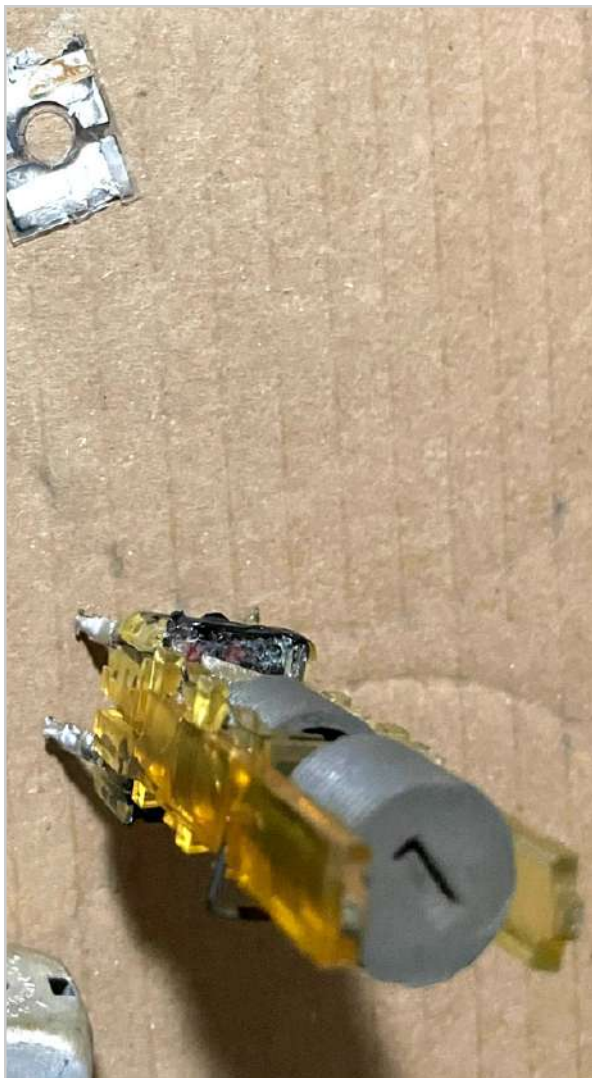
Here is an IF transformer made by Automatic reassembled after removal of the mica sheet.
