# The Jersey Broadcaster

NEWSLETTER OF THE NEW JERSEY ANTIQUE RADIO CLUB

May 2026

## A Deep Dive Into the All-American Five (What About That Tingle?)

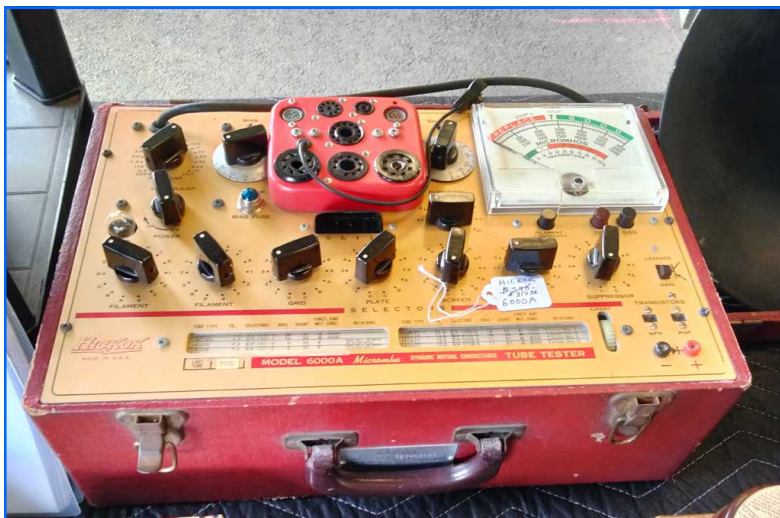
Hickok 6000A Tube Tester

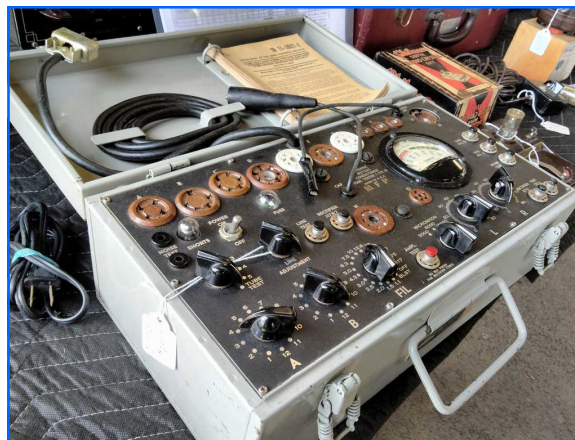
Hickok I77B Tube Tester

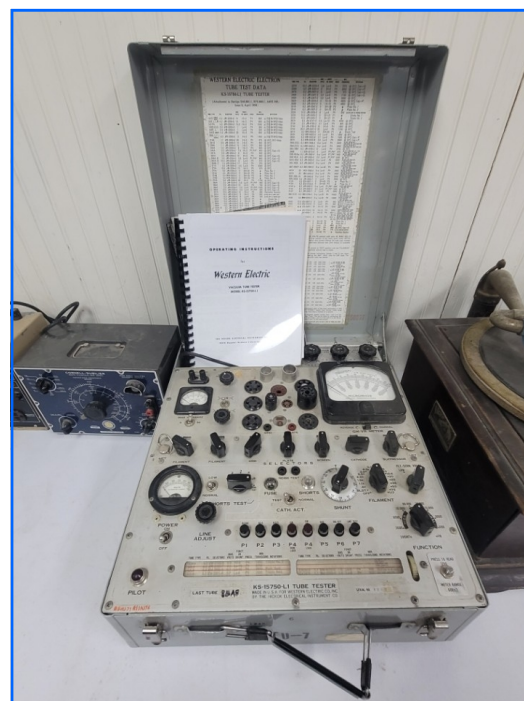
Western Electric 15750 Tube Tester

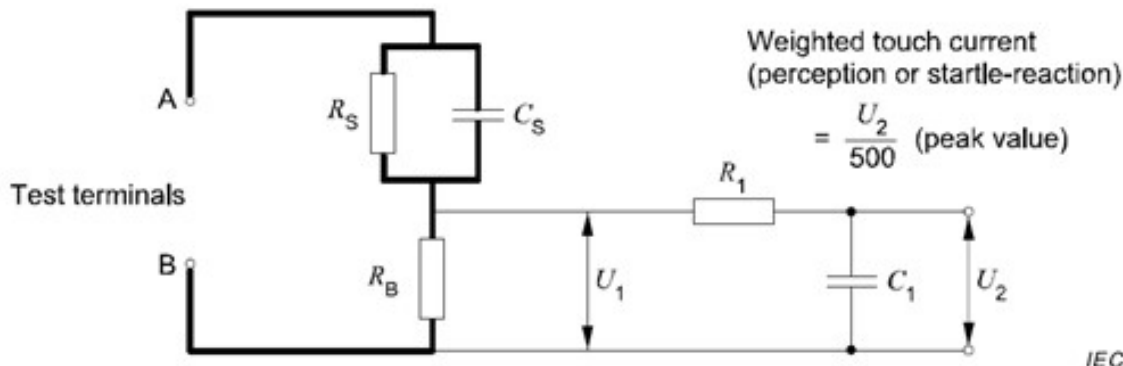
The circuit below seems to meet the basic criterion of Reference 5 which basically follows the original 1945 UL measurement method. It uses a 1500 ohms resistor to simulate the average human body resistance and a 500 ohm resistor to simulate the ammeter resistance. Added to the 1945 circuit is the simulated body capacitance in parallel with the body resistance. There is also an RC network which is used to filter and average the measured voltage readings. The leakage current is then calculated by the measured voltage (U2) divided by 500 ohms. The typical DVM has an input impedance of 10 meg no matter the voltage range. This will have no measurable affect on the voltage dropped across the 500 ohm resistor.

$R_S$	1 500 $\Omega$	$R_1$	10 000 $\Omega$
$R_B$	500 $\Omega$	$C_1$	0,022 $\mu F$
$C_S$	0,22 $\mu F$

The calculated reactance of the capacitor that connects the S-38 chassis to the case controls the maximum AC leakage current that is available to shock the user. The smaller the external resistance to the power line neutral, the lower the external AC voltage drop. The higher the external resistance to power line neutral, the higher the external AC voltage drop.

Using the above Leakage Current Measuring circuit and my recapped S-38, I measured the leakage current per the European Specification. With the chassis connected to the AC line neutral the highest available current was 11.8  $\mu a$  which is well below one's ability to feel. See Reference 6.

With the chassis connected to the AC hot lead, the chassis was at 120vac. The  $U_2$  voltage measured at the chassis was 31vac and the calculated current was 31vac / 500ohms = 62ma which is over 10 times the present

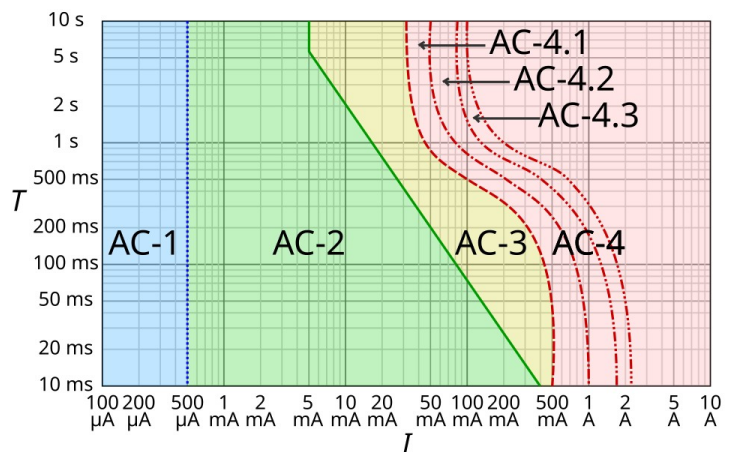
Log-log graph of the effect of alternating current I of duration T passing from left hand to feet as defined in IEC 60479

- AC-1: imperceptible
- AC-2: perceptible but no muscle reaction
- AC-3: muscle contraction with reversible effects
- AC-4.1: up to 5% probability of ventricular fibrillation
- AC-4.2: 5–50% probability of fibrillation
- AC-4.3: over 50% probability of fibrillation

To get an idea of what these leakage currents mean to the average individual, see the log-log graph, Reference 6. This graph shows the relationship between current and time, the very definition of the Coulomb. What determines the lethality of any current conducted through the human body is both the amount of the current and the amount of the time that the current flows. It's complicated. "There's always something... if it's not one thing, it's another" - Roseanne Roseannadanna aka Gilda Radner.
